Manhole Inspection Summary

Manhole # S53G__022MH

Insp Date: **4/15/08 9:43 AM**

Location Address: **3211 E Pratt St**

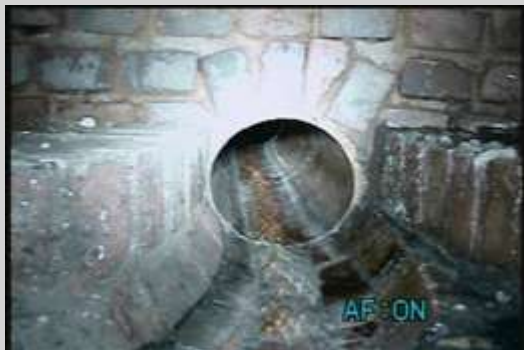
12 O'Clock Outflow

8 in. Circular Gravity Sewer
Pipe Out @ 12 O'Clock

Invert Depth: 8.25 (ft.) Flow Characteristics: Fast

Infiltration: None Pipe Seal Cond: Unknown

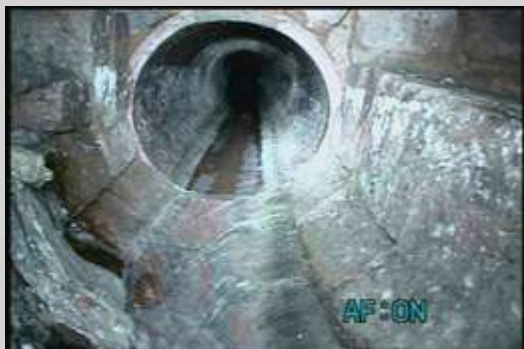
9 O'Clock Inflow

8 in. Circular Gravity Sewer
Pipe In @ 9 O'Clock

Drop In @ 9 O'Clock

Infiltration: None Pipe Seal Cond: Unknown

Drop Condition: Open
